Governors Island, Fort Columbus (Fort Jay)

HABS No. NY-5715-1B

Building #206

GOVERNORS ISLAND, FORT COLUMBUS (FORT JAY)
BUILDING #206

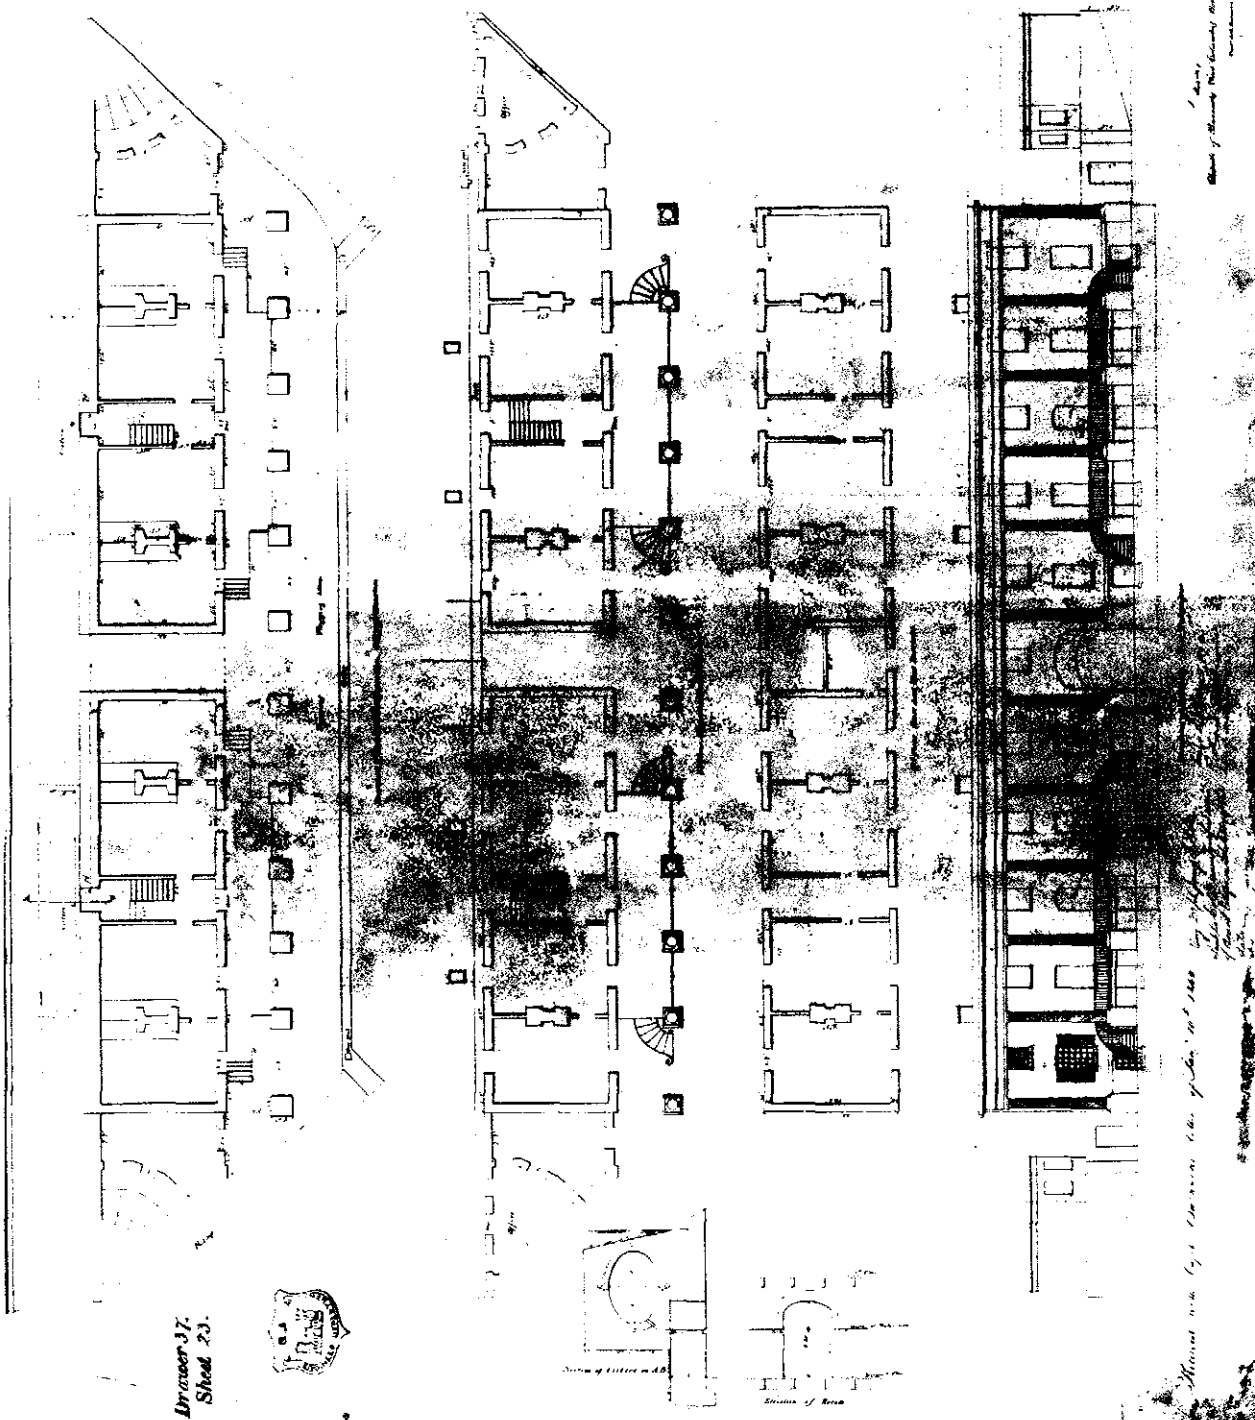
Photocopy of Drawings of Officer's Quarters, Fort Columbus, New York
National Archives, Record Group 92
Records of the Office of the Quartermaster General
Consolidated Correspondence File, 1794-1890
Plans of Alterations of Barracks, Fort Columbus
Drawn by Colonel James Bankhead, 1844

6. Alterations and additions: Soon after construction, the plan of the barracks buildings was found to be unsatisfactory. A Board of Officers appointed to examine the conditions of the barracks and quarters on the Island reported in 1839 that the buildings did "not seem to be well adapted to the purposes for which they were designed." According to the Board, the rooms were too small and poorly ventilated, and inappropriately placed windows subjected the men to sudden changes of weather. Space allotted for colonnades on the front of the buildings could have been more wisely used to enlarge the rooms. The Board also felt that expanding the parade ground by placing the buildings next to the terreplein wall was unwise, since it allowed no space for exits at the rear of the buildings. Actually, removal of the barracks from their earlier position had not added sufficiently to the open space within the fort, and its use as a parade ground remained limited. To alleviate some of these problems, plans for making the interiors more functional were proposed by Colonel James Bankhead in 1844 (Plate 2). Iron balconies accessible by exterior stairs were to be placed on the second story of all four buildings, and windows at the ends and center were to be converted to doors opening onto the balconies. Interior stairways could then be removed and the rooms enlarged in the enlisted barracks.

Proposed Alterations to the Barracks and Officers' Quarters within Fort Columbus, 1844. Filed with Colonel James Bankhead to Brigadier General R. Jones, November 5, 1844. Box 98, Colonel James Bankhead, Record Group 92, Office of the Quartermaster General, Consolidated Correspondence File, 1794-1915, Navy and Old Army Branch, National Archives. The proposed alterations were not done at the time.

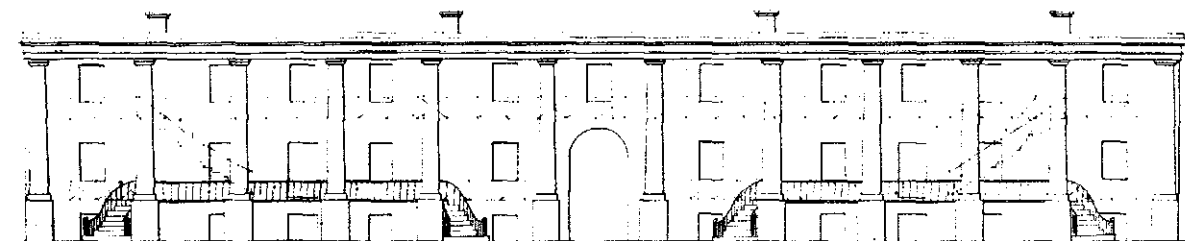
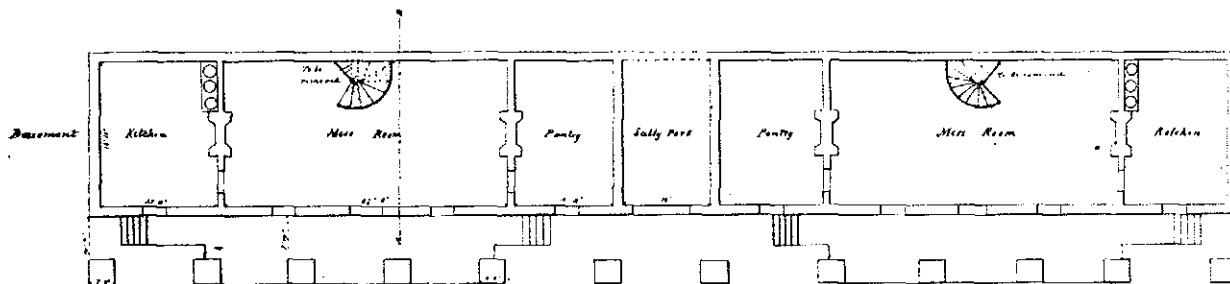
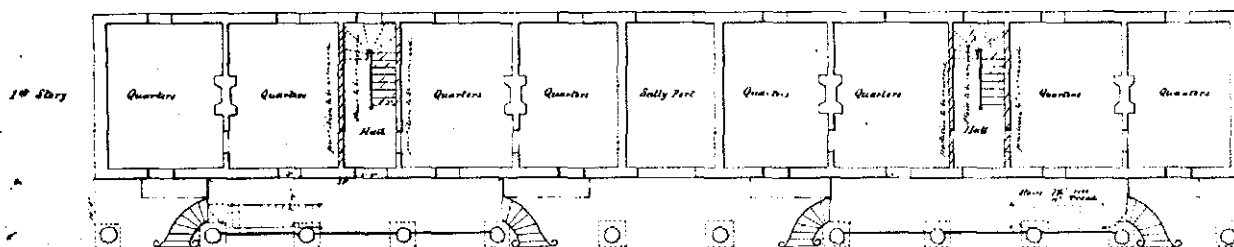
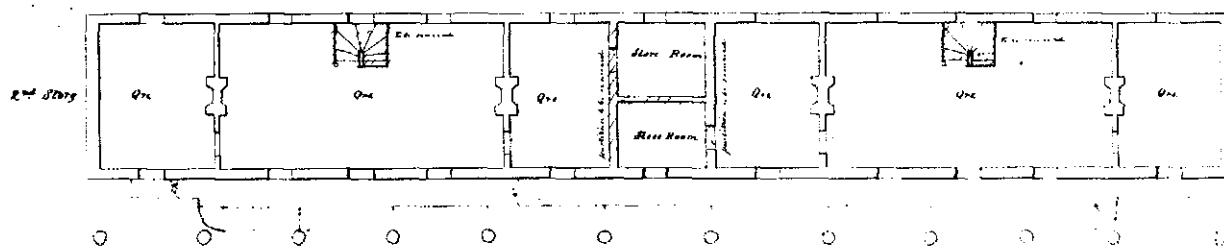
1. Proposed alteration in SOLDIERS QUARTERS in Fort Columbus Governors Island N.Y.

Front Elevation

Plan of Basement

Plan of 1st Story

Section on A-B

at B The black line indicates the present arrangement
The red line the proposed alterations

Photocopy of Drawings of Soldier's Quarters, Fort Columbus, New York
National Archives, Architectural and Cartographic Branch
Record Group 77-Fortifications File, Drawer 37, sheet 39
Proposed Alteration in Soldiers Quarters in Fort Columbus
Drawn by J.B. McPherson, April 1855

The proposed changes were apparently not made in the mid-1840s since another set of alterations to the buildings was proposed in 1855. Plate 3 illustrating proposed changes in the floor plan and exterior stairways which differed little from the earlier proposals was submitted to the Chief of Engineers. The drawing does illustrate a further alteration not recommended in

Proposed Alteration in Soldiers Quarters in Fort Columbus, 1855. Fortification File, Fort Columbus Drawer 37, sheet 39. Alterations were probably completed shortly after the plans were submitted.

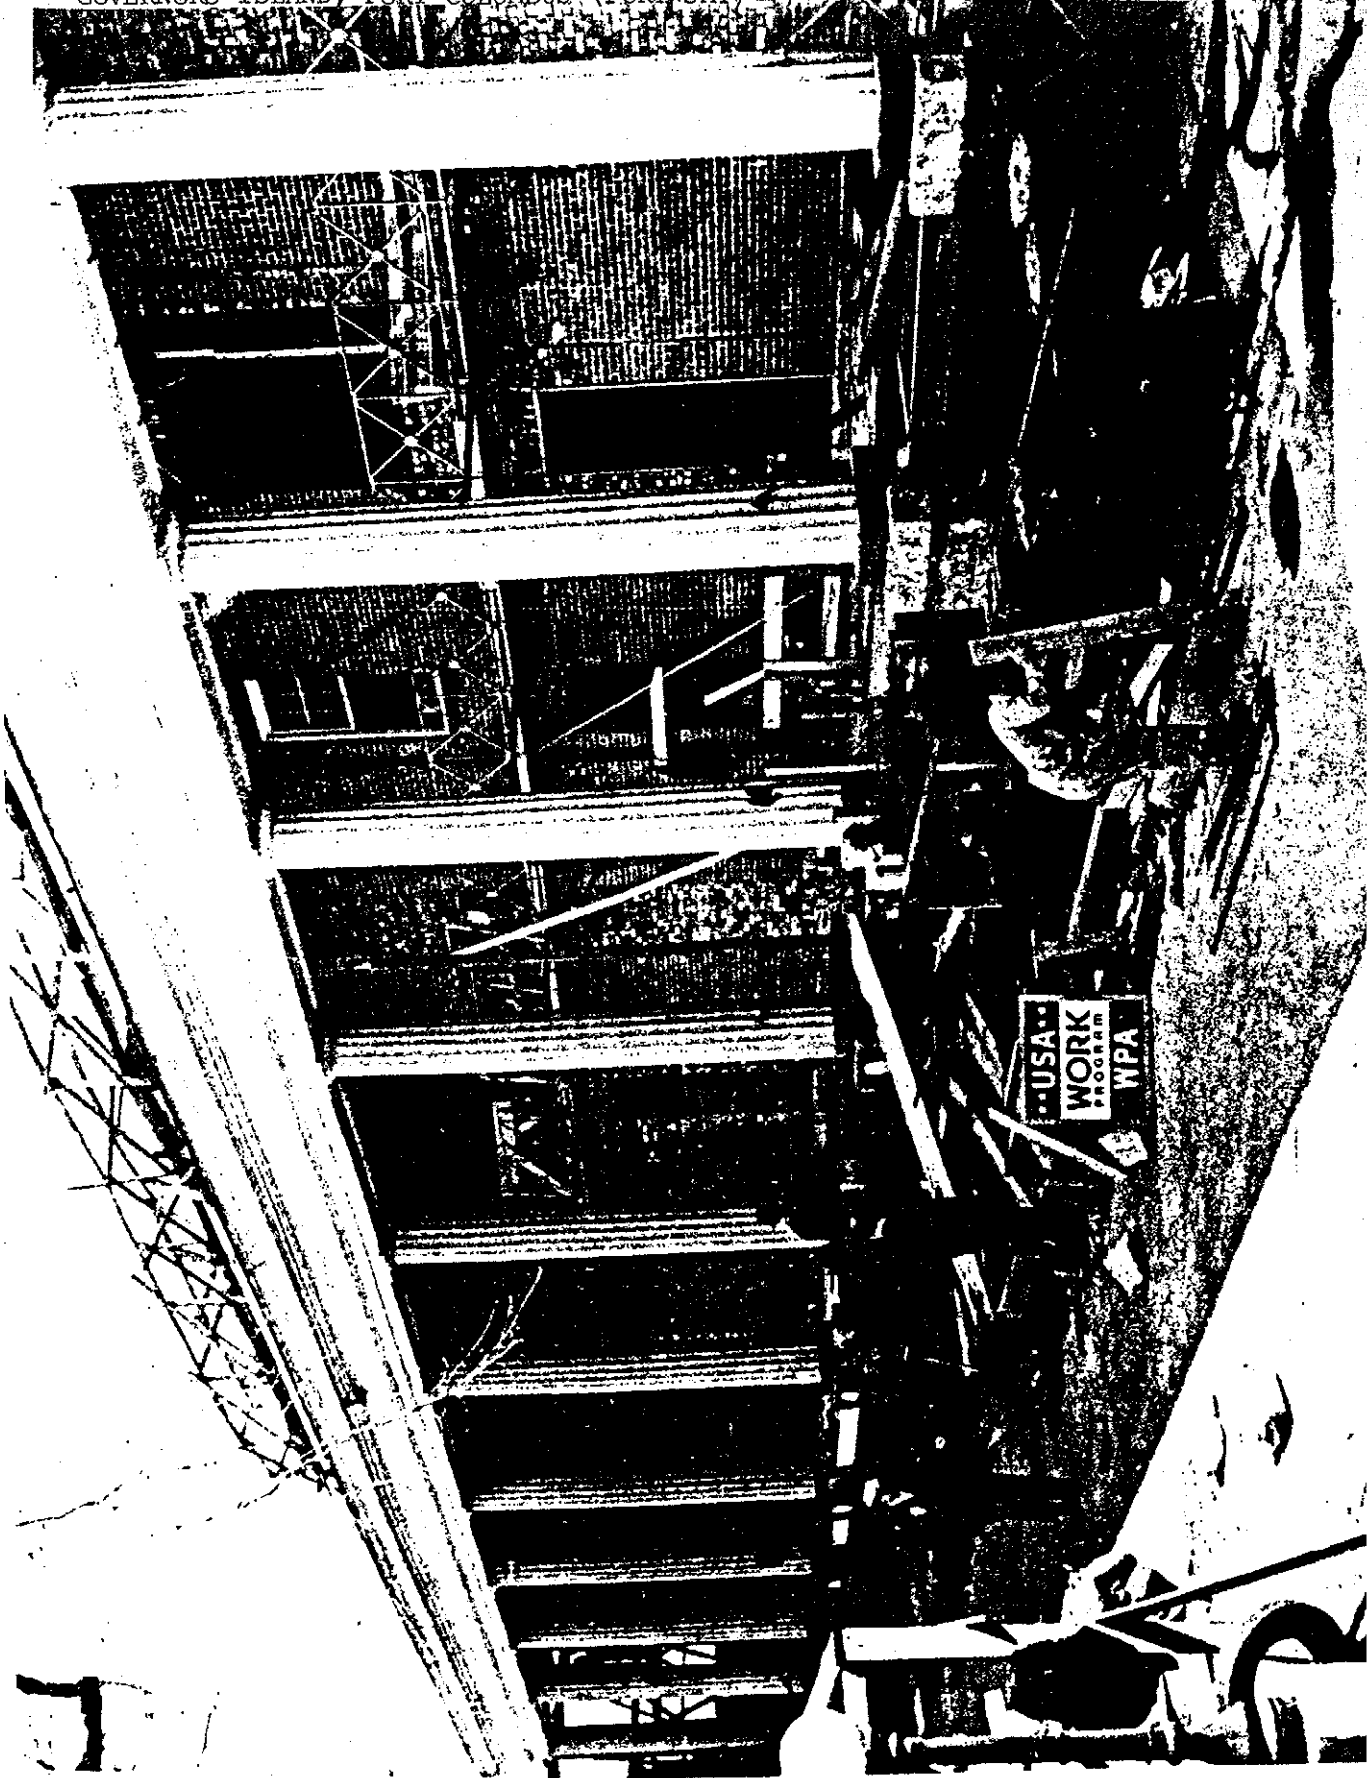
Plate 5

Reprint of Photograph of Building #206
Special Services Branch, Support Center, New York
Exterior View of WPA Conversion
Unknown Photographer, February 2, 1938

In 1936-38 the interior was altered once again. The interior was gutted, and the plan was changed to four two-story units above basement maid and utility rooms. The plan changes necessitated alterations to the building's fenestration pattern as well. Architectural drawings documenting these alterations are on file in the Coast Guard Facilities Engineering Division on Governors Island. (Copies are contained in the photographs following the Bibliography, HABS No. NY-5715-1B-7 through NY-5715-1B-9.) WPA work is further documented in photographs (Plates 5-6) located in the Special Services Office on the Island. Double brick garages were built in the bastions at the same time.
